# Advanced Home Inspection

## Confidential Inspection Report

INSPECTED ON:  
Thursday, August 22, 2024

Inspector, Bradley Gamlin 3380001125NRS  
Advanced Home Inspection

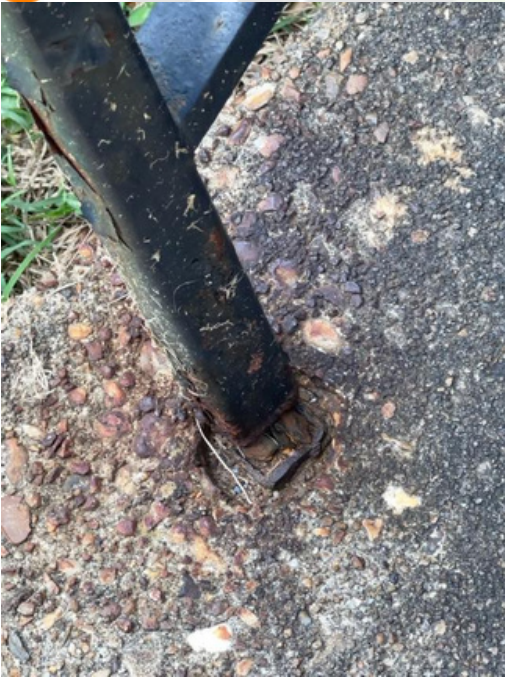
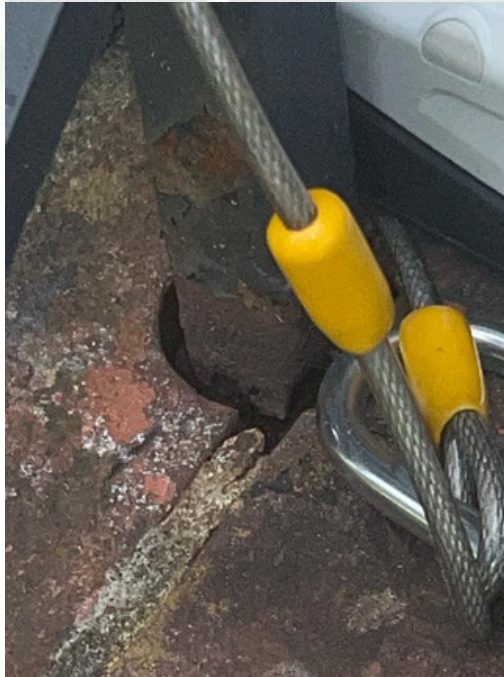
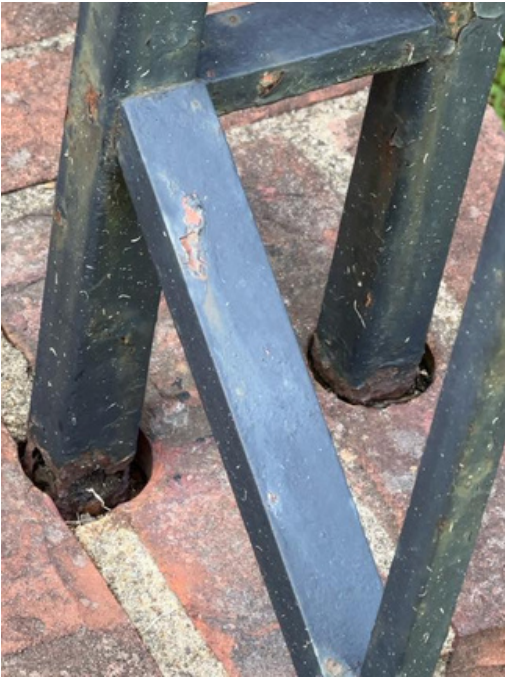
**REP** s-23: The railings at the front are deteriorated. We recommend they be repaired or replaced. ~\$1,200 - \$1,500

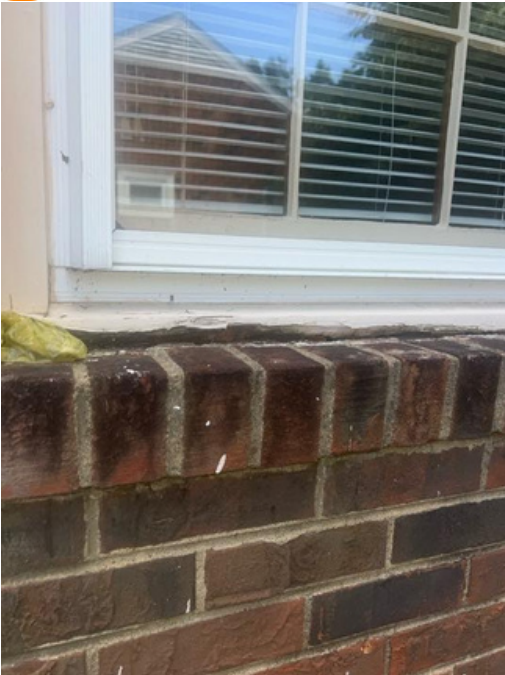
Right side

**REP** s-25: The trim is deteriorated. We recommend it be repaired or replaced. ~\$200

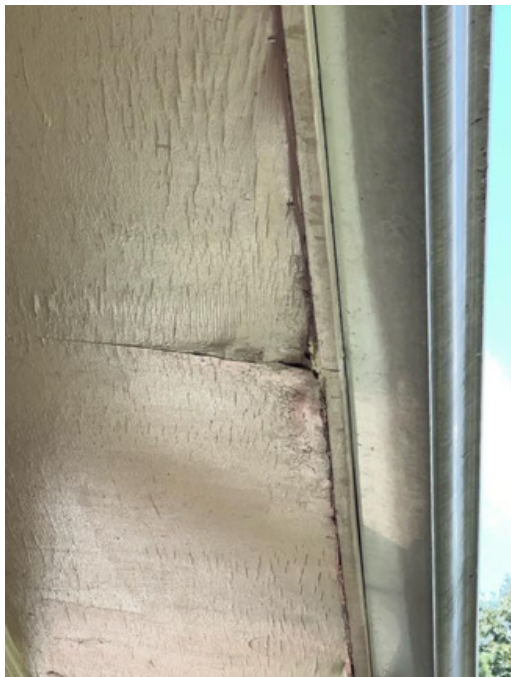
**REP** s-28: EAVES: Sections of the eaves at the front are deteriorated. We recommend repair or replacement. ~\$250

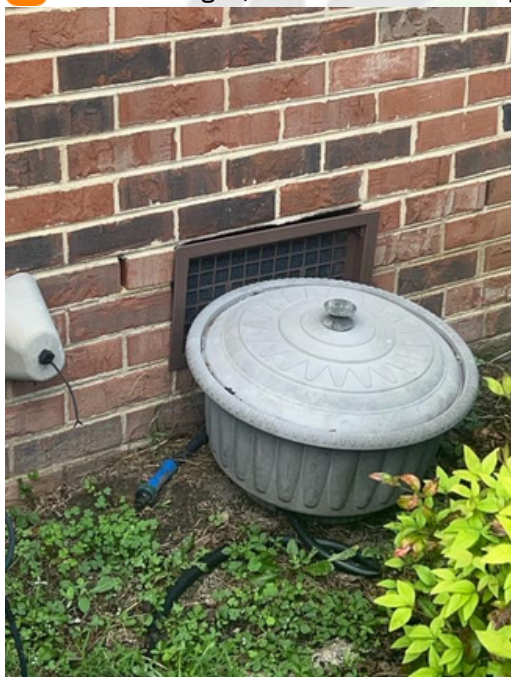
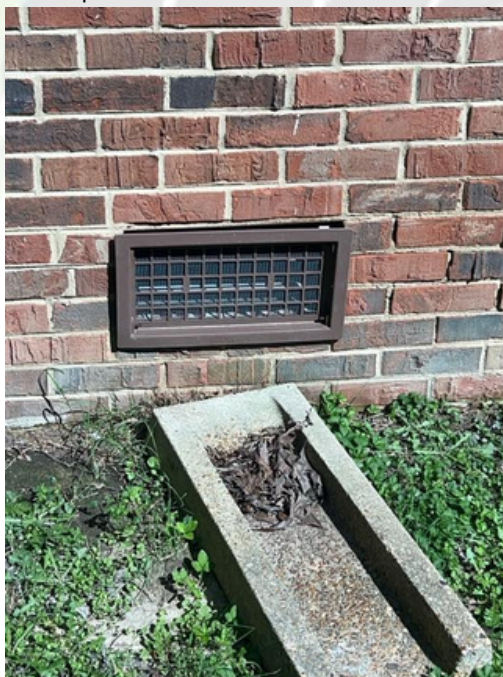
**REP** s-48: Damaged/loose vents noted. Replace or repair. ~\$100

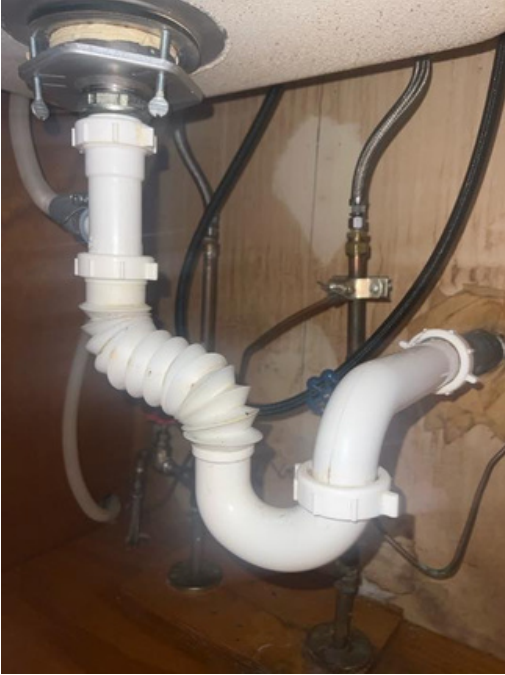
**REP s-85:** The flexible rubber or plastic fitting used in the drain trap is nonconforming and considered temporary. We recommend replacement with a more permanent solution. ~\$150

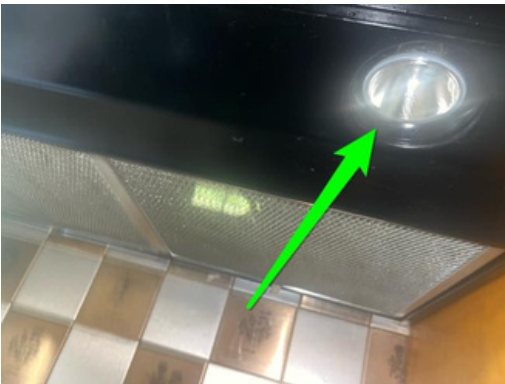
**REP s-89:** The light is not working. The bulb may have burned out. We recommend that the bulb be tested and replaced, if necessary, and the proper operation of the fixture be verified. ~\$75

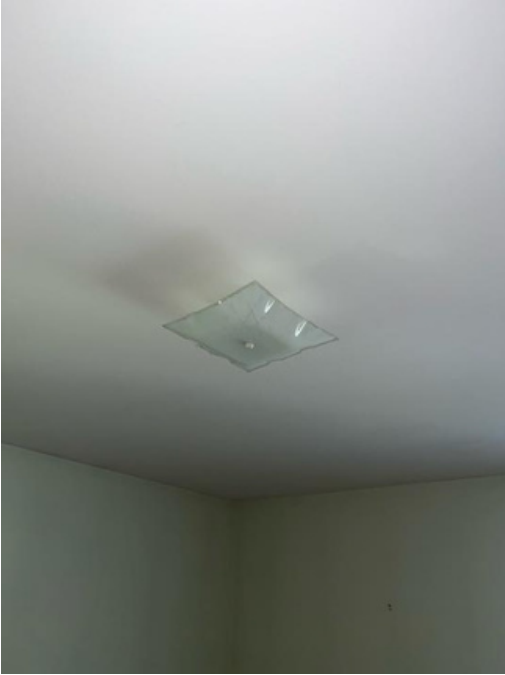
**REP** **s-127:** The light is not working. The bulb may have burned out. We recommend that the bulb be tested and replaced, if necessary, and the proper operation of the fixture be verified. **~\$75**

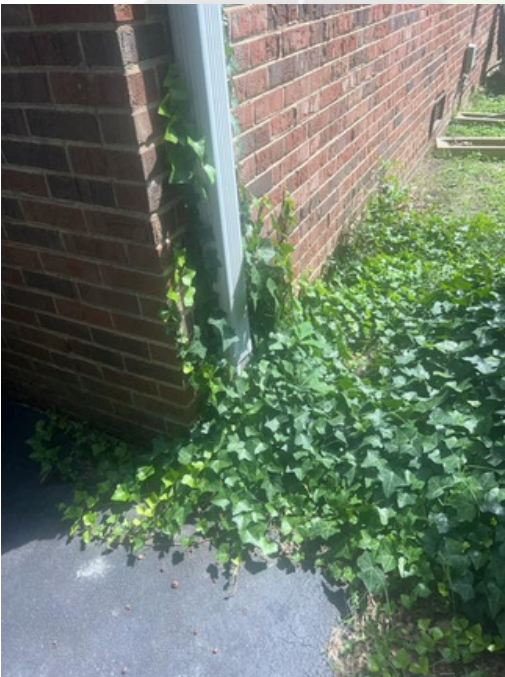
**MAIN** **s-24:** There is ivy growing on the building. Ivy can be very pleasing aesthetically, but it can promote insect and rodent infestation and moisture penetration. We recommend the ivy be removed from the walls to avoid damage to trim, eaves, gutters, etc.

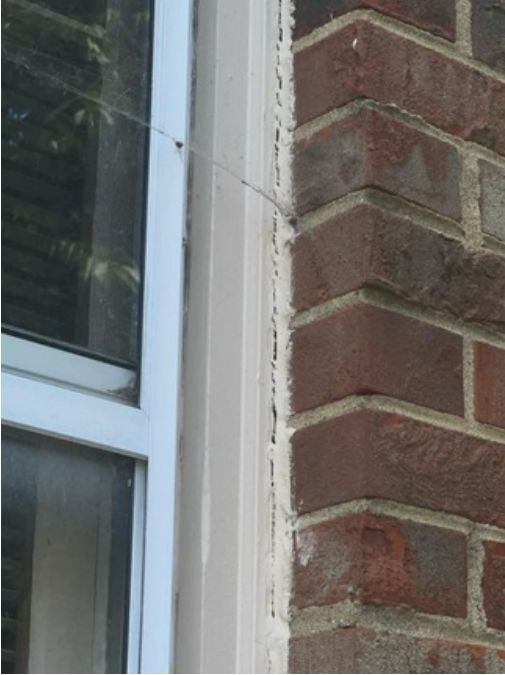
**MAIN s-26:** There are openings at seams and joints of the trim. We recommend recaulking and sealing to prevent moisture entry and damage.

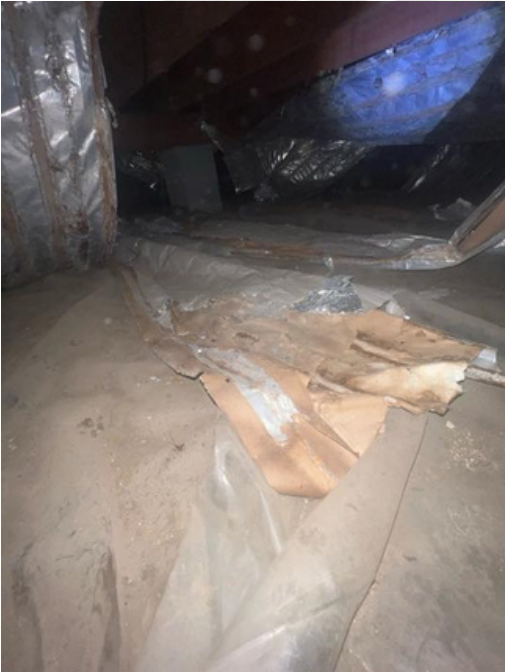
**UPGR s-46:** Portions of the soil are covered by a vapor barrier. This is considered a beneficial feature. We recommend completing the installation so that all exposed soil is covered by a vapor barrier.

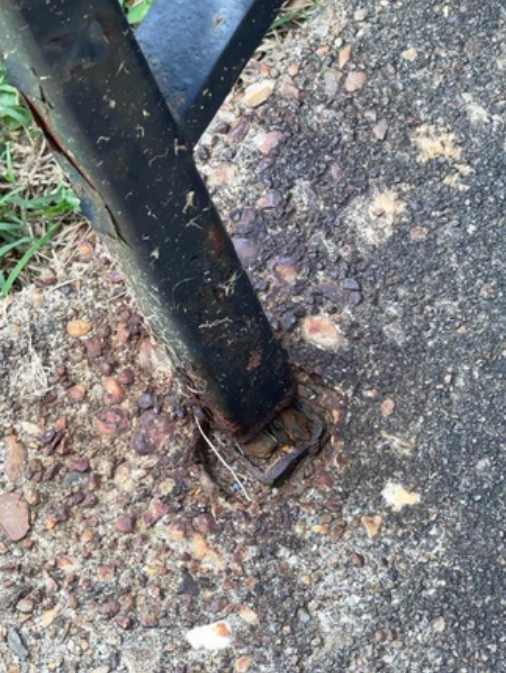
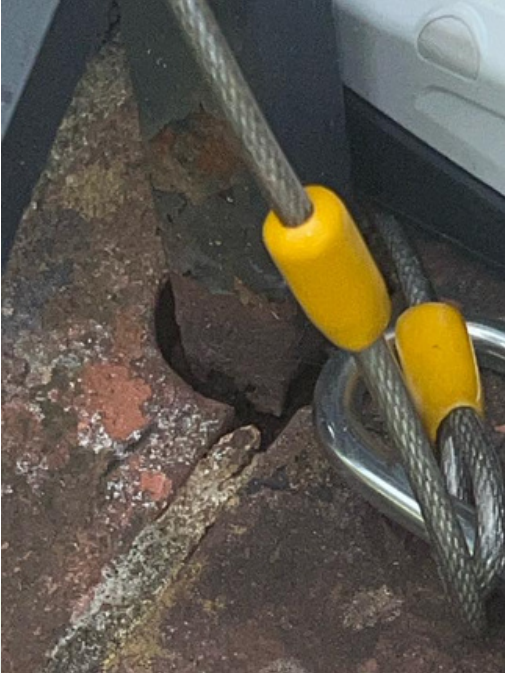
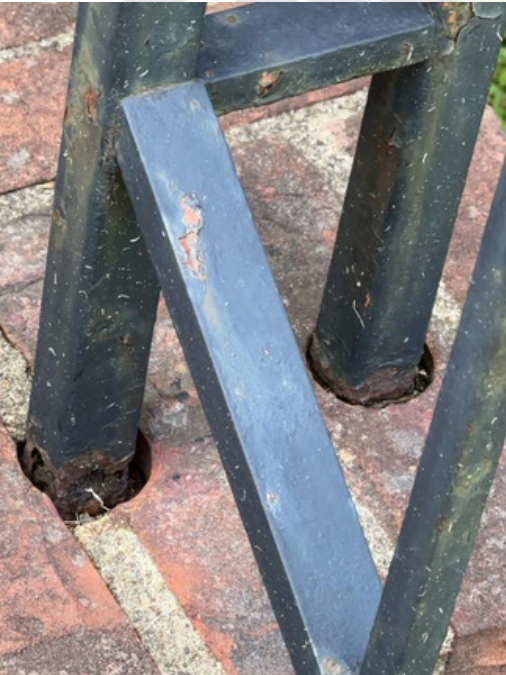
**REP 23:** The railings at the front are deteriorated. We recommend they be repaired or replaced. ~\$1,200 - \$1,500

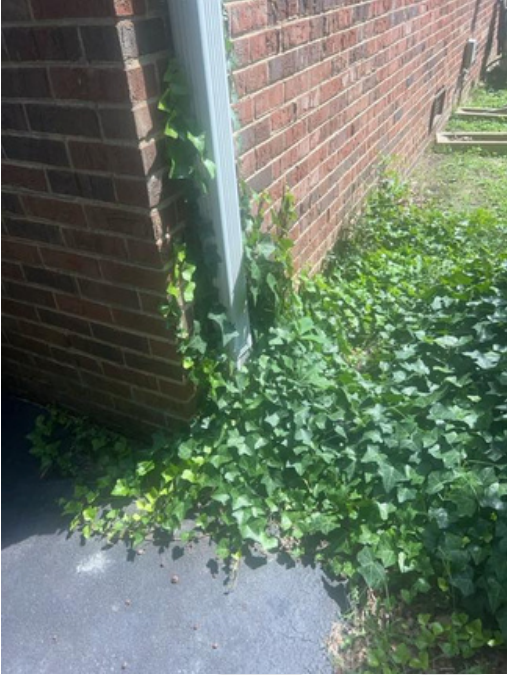
**MAIN 24:** There is ivy growing on the building. Ivy can be very pleasing aesthetically, but it can promote insect and rodent infestation and moisture penetration. We recommend the ivy be removed from the walls to avoid damage to trim, eaves, gutters, etc.

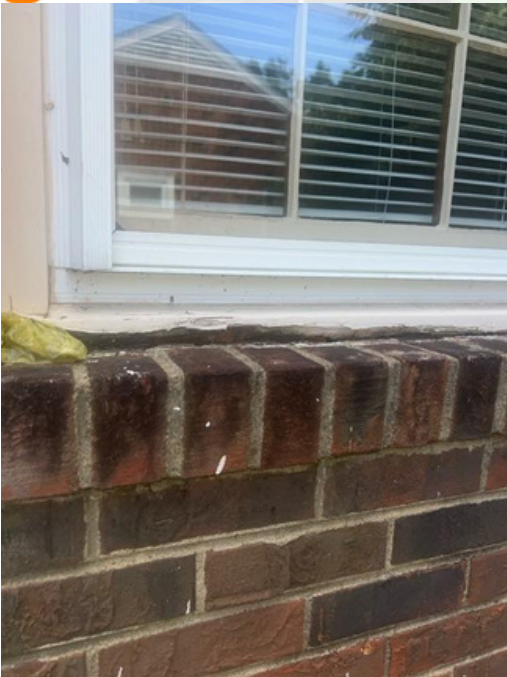
Right side

**REP 25:** The trim is deteriorated. We recommend it be repaired or replaced. ~\$200

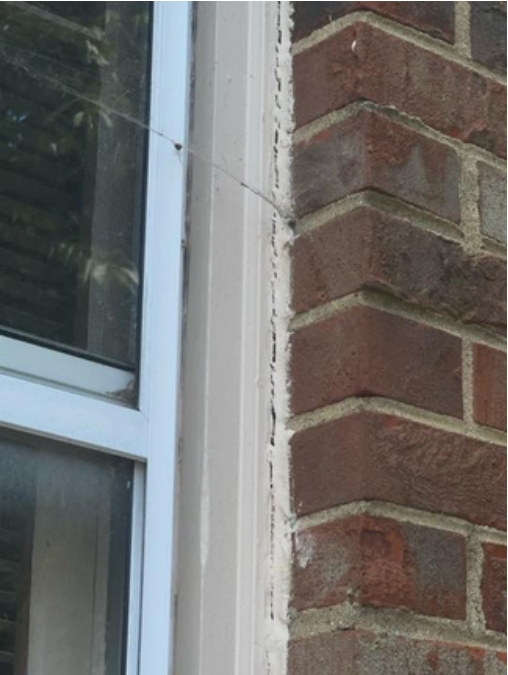
**26:** There are openings at seams and joints of the trim. We recommend recaulking and sealing to prevent moisture entry and damage.

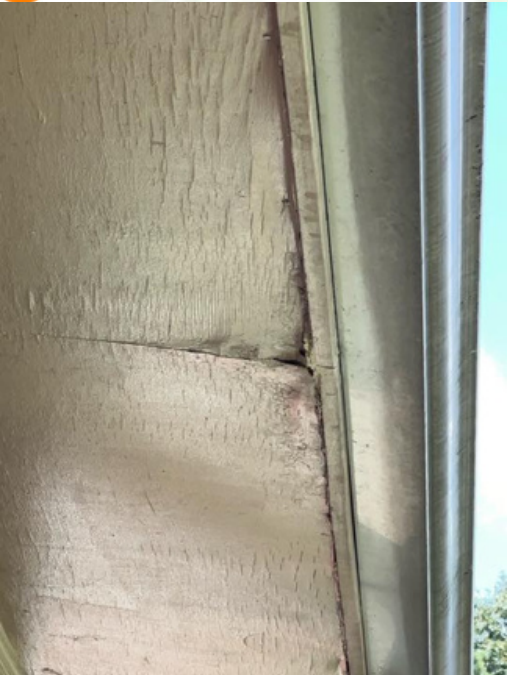
**28: EAVES:** Sections of the eaves at the front are deteriorated. We recommend repair or replacement. ~\$250

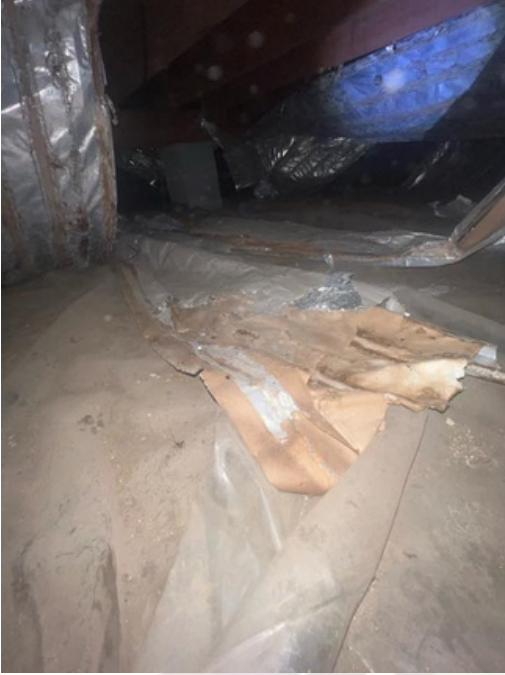
**UPGR** **46:** Portions of the soil are covered by a vapor barrier. This is considered a beneficial feature. We recommend completing the installation so that all exposed soil is covered by a vapor barrier.

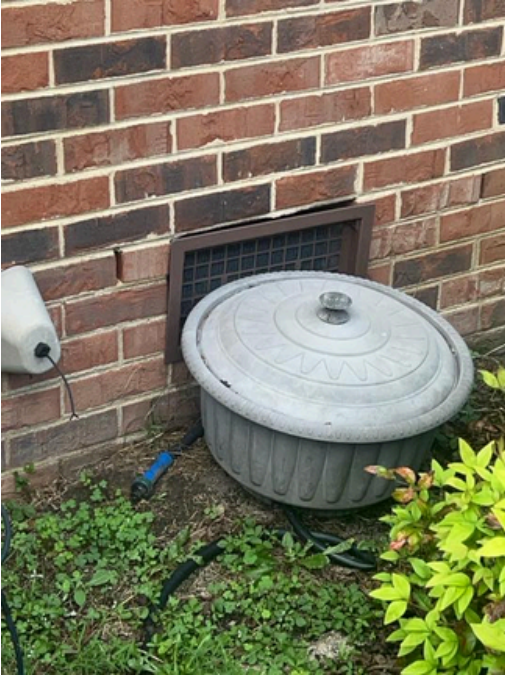
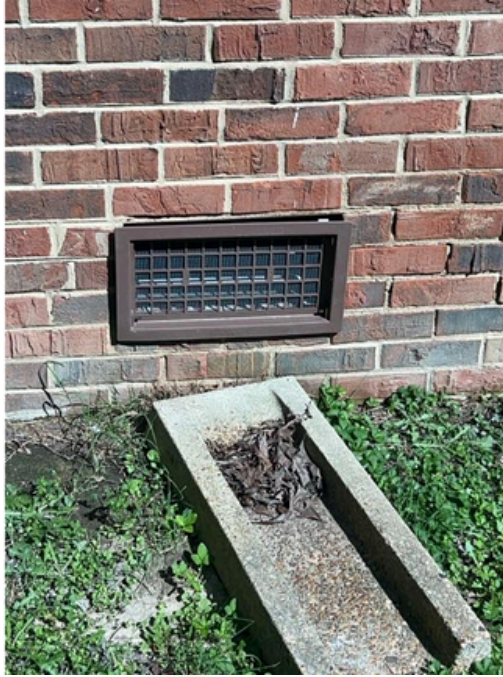
**REP** 48: Damaged/loose vents noted. Replace or repair. ~\$100

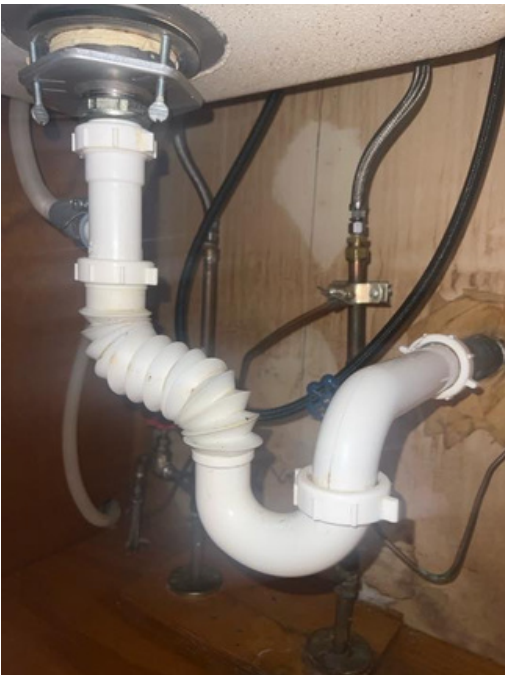
**REP 85:** The flexible rubber or plastic fitting used in the drain trap is nonconforming and considered temporary. We recommend replacement with a more permanent solution. ~\$150

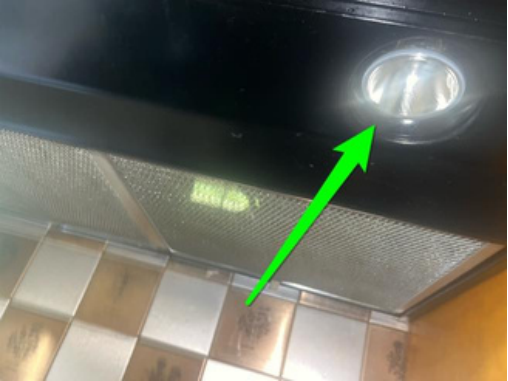
**REP 89:** The light is not working. The bulb may have burned out. We recommend that the bulb be tested and replaced, if necessary, and the proper operation of the fixture be verified. **~\$75**

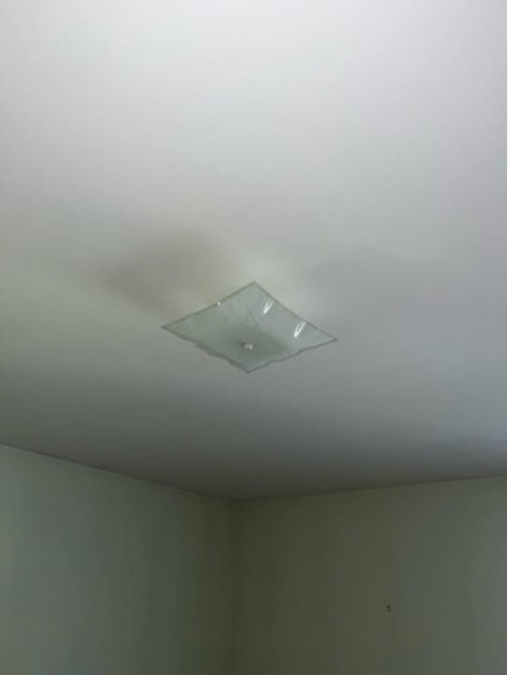
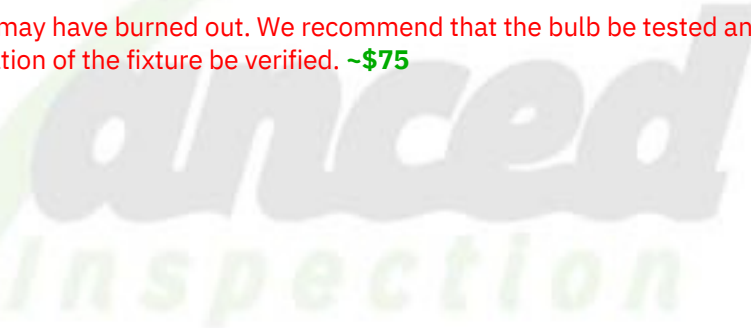
**REP 127:** The light is not working. The bulb may have burned out. We recommend that the bulb be tested and replaced, if necessary, and the proper operation of the fixture be verified. **~\$75**
